# Kaka

## PWSID No. 0400037

Sanitary Survey  
March 22, 2016

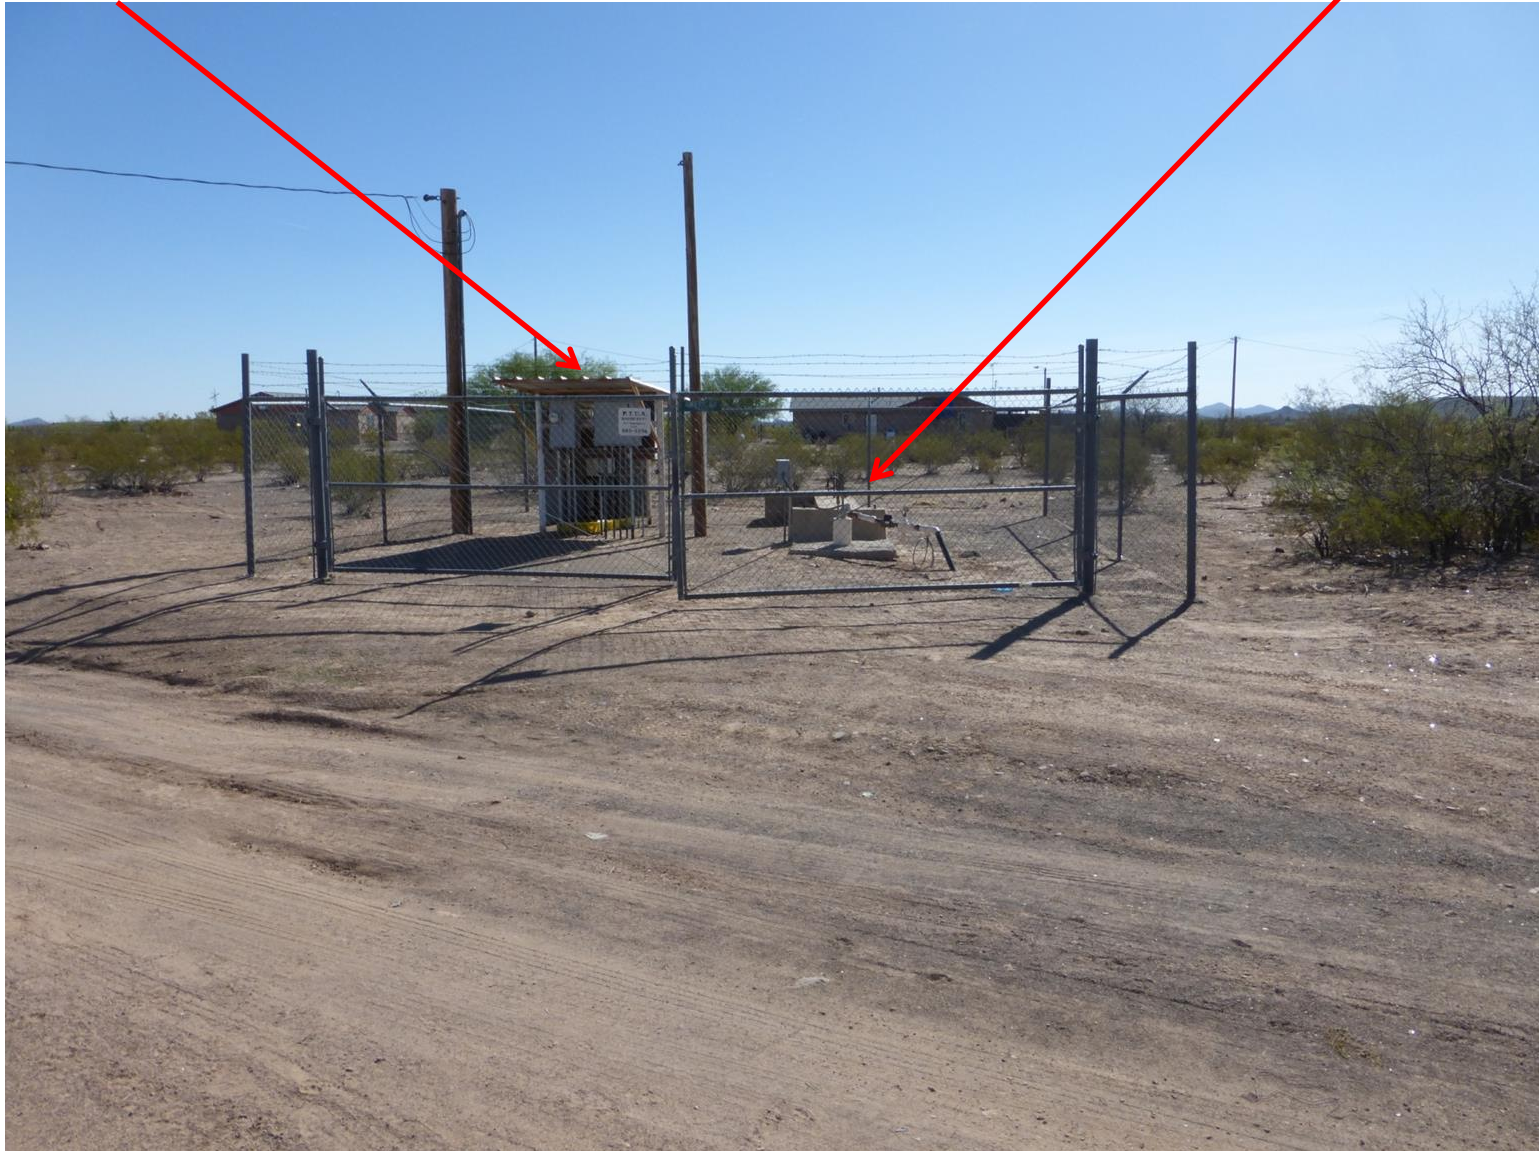
**The well was drilled and cased to a depth of 700 feet in 1977. The static water level is 635 feet. The well is equipped with a 10-hp pump that produces approximately 30 gpm.**

There is no sample tap following the point of chlorine injection.

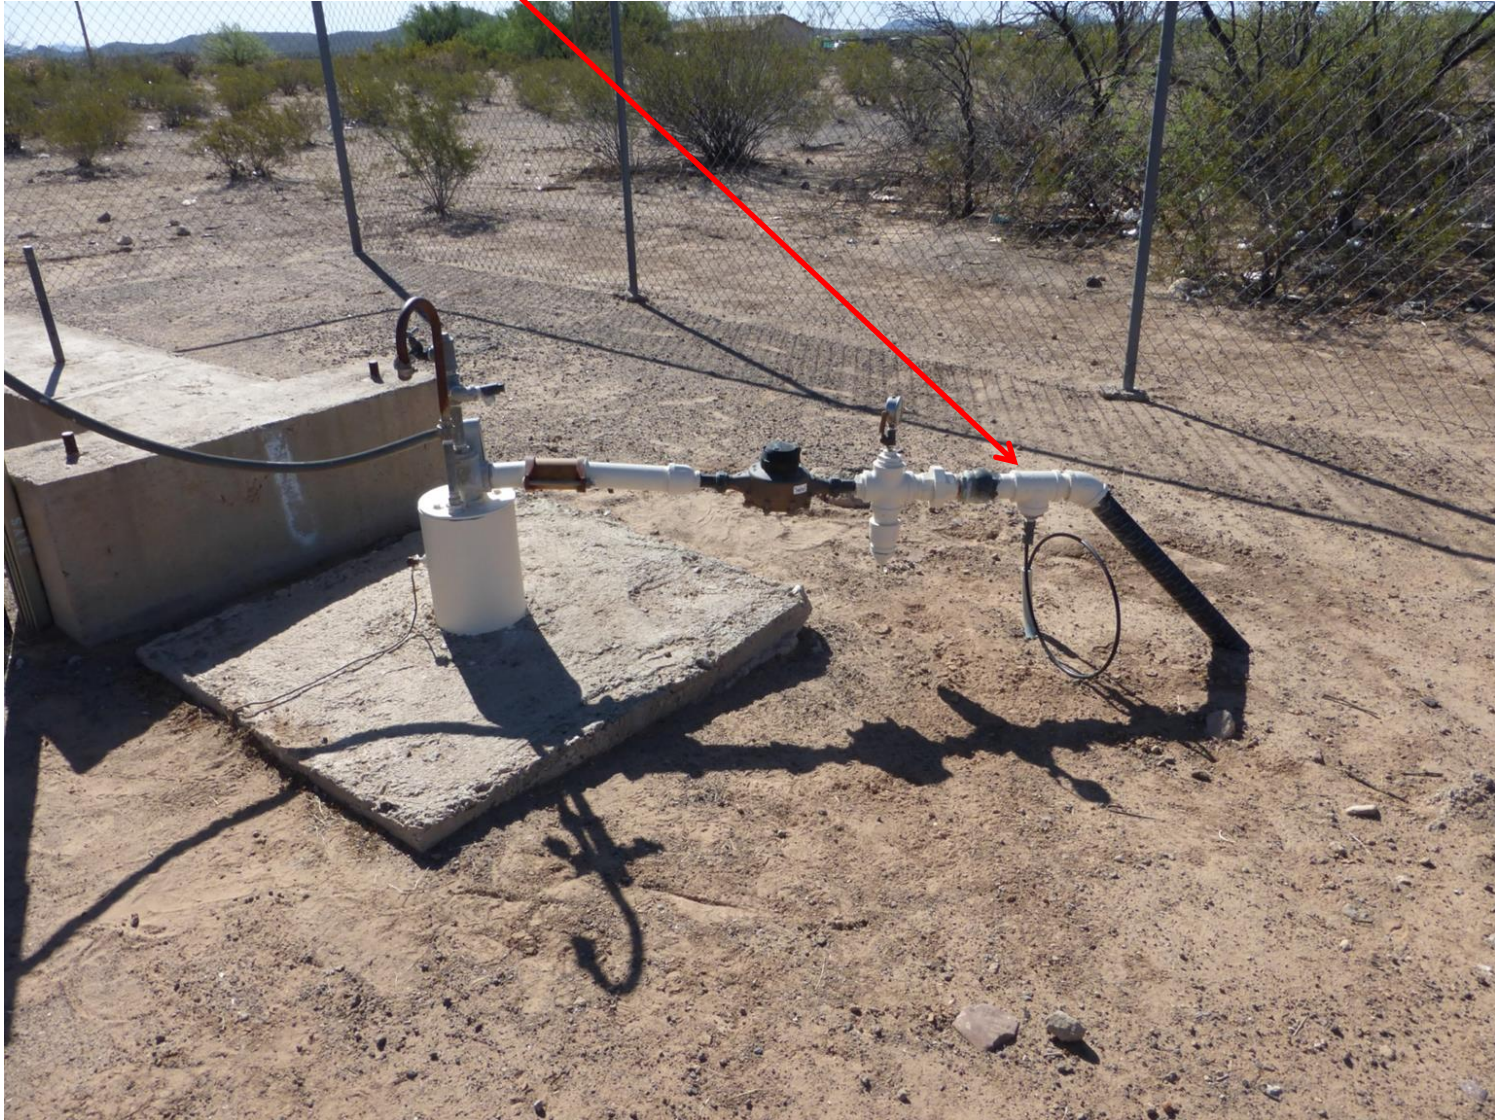
**Well 1 (GW001)**

The well cap consists of a gasketed sanitary seal well cap that is properly vented. Appurtenances on the well discharge piping include a pressure relief valve, a raw water sample tap, a water meter, and a pressure gauge. There is no treated water sample tap.

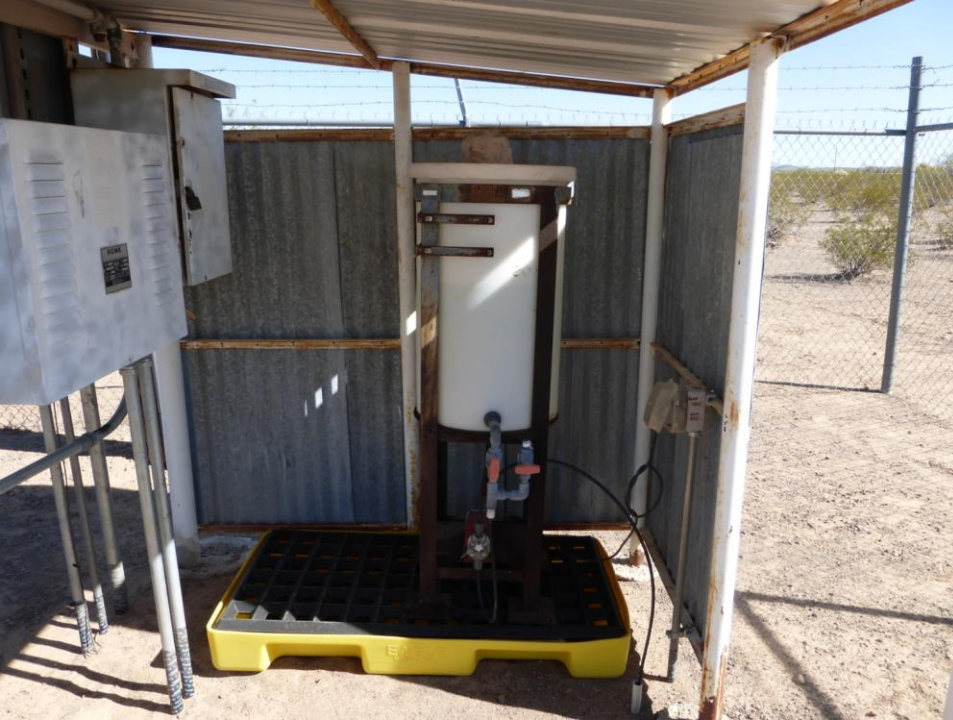
## Chlorination Unit for Well 1 (TP001)

Treatment for Well 1 consists of chlorination with sodium hypochlorite. The NSF-certified sodium hypochlorite is diluted and injected in the well's discharge piping with a ProMinent ConceptPlus positive displacement pump with a capacity of 0.26 gph.

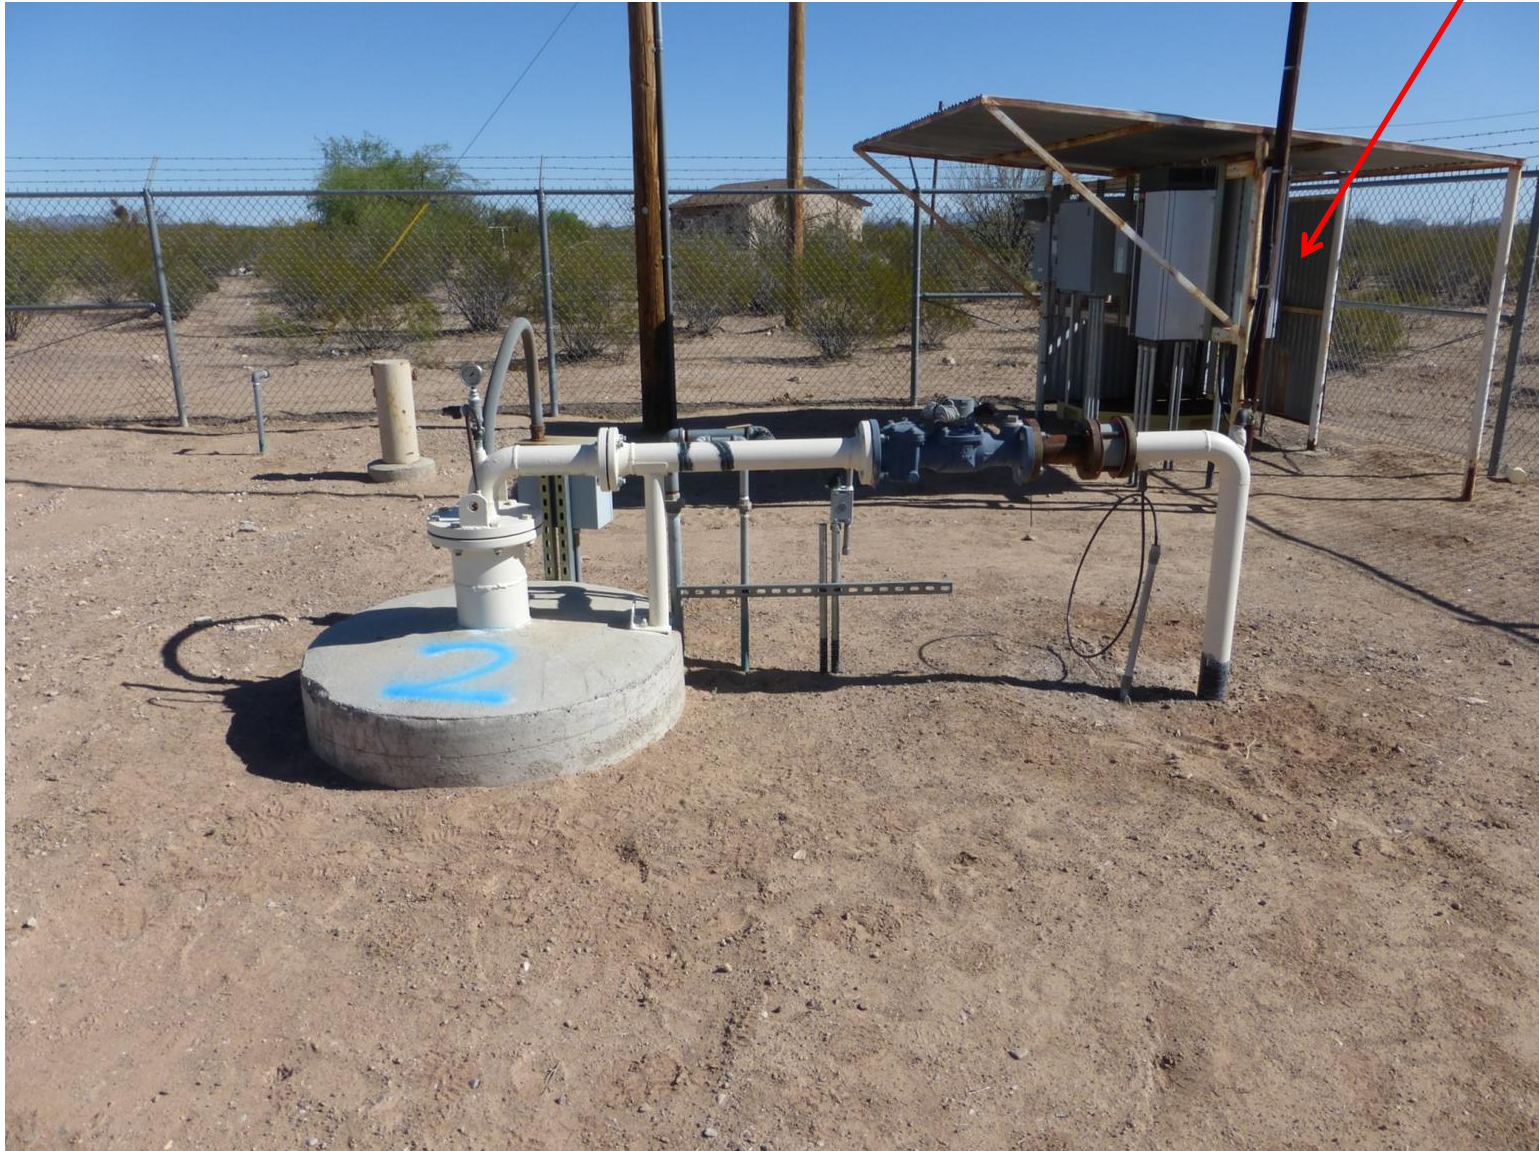
**Well 2 (GW002)**

**The well was drilled and cased to a depth of 756 feet in 2000. The static water level is 628 feet. The well is equipped with a 20-hp pump that produces approximately 70 gpm.**

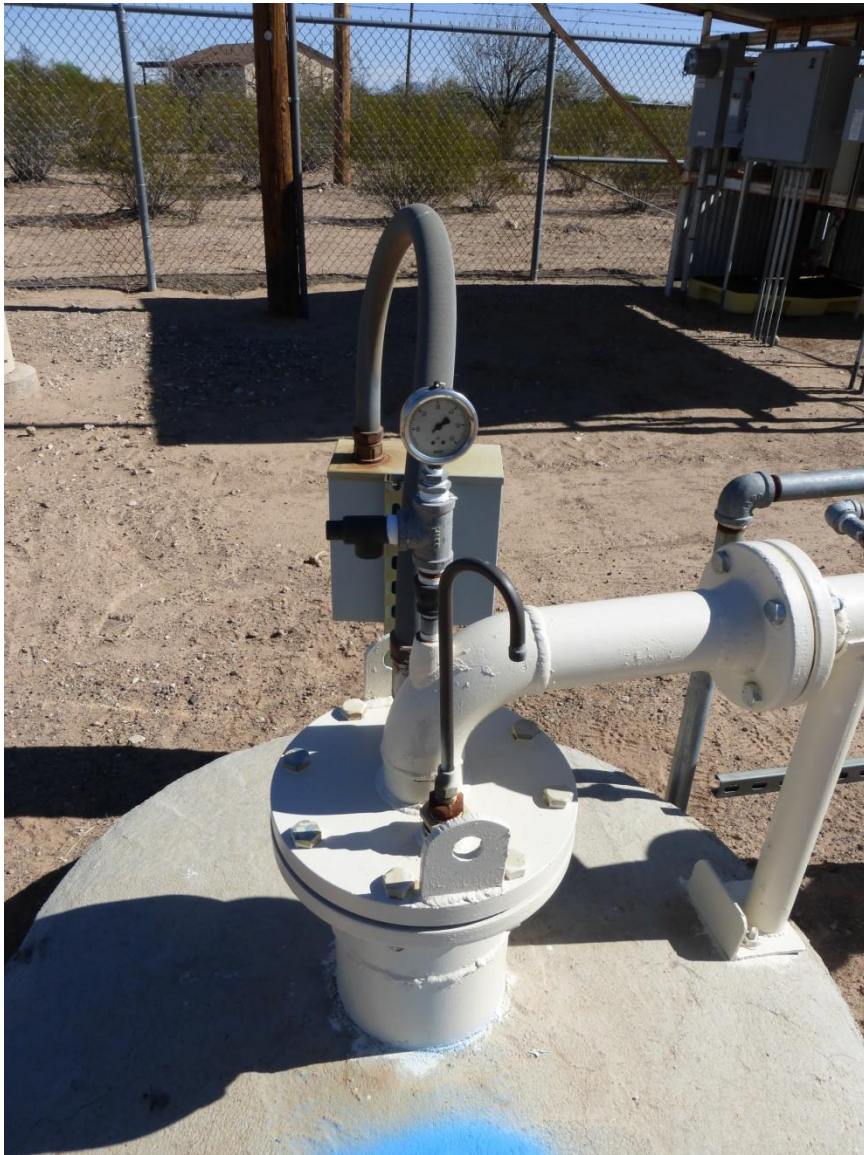
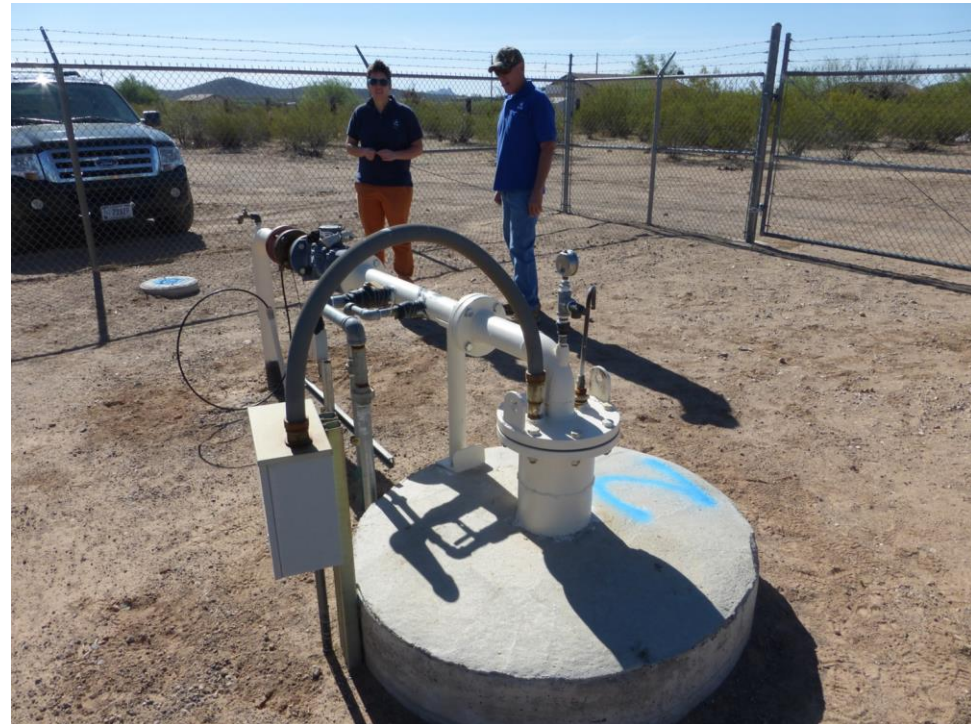
## Well 2 (GW002)

The wellhead is equipped with a properly vented sanitary seal well cap. Appurtenances on the well discharge piping include a raw water sample tap, pressure relief valve, pressure gauge, blowoff line, water meter, and a treated water sample tap.

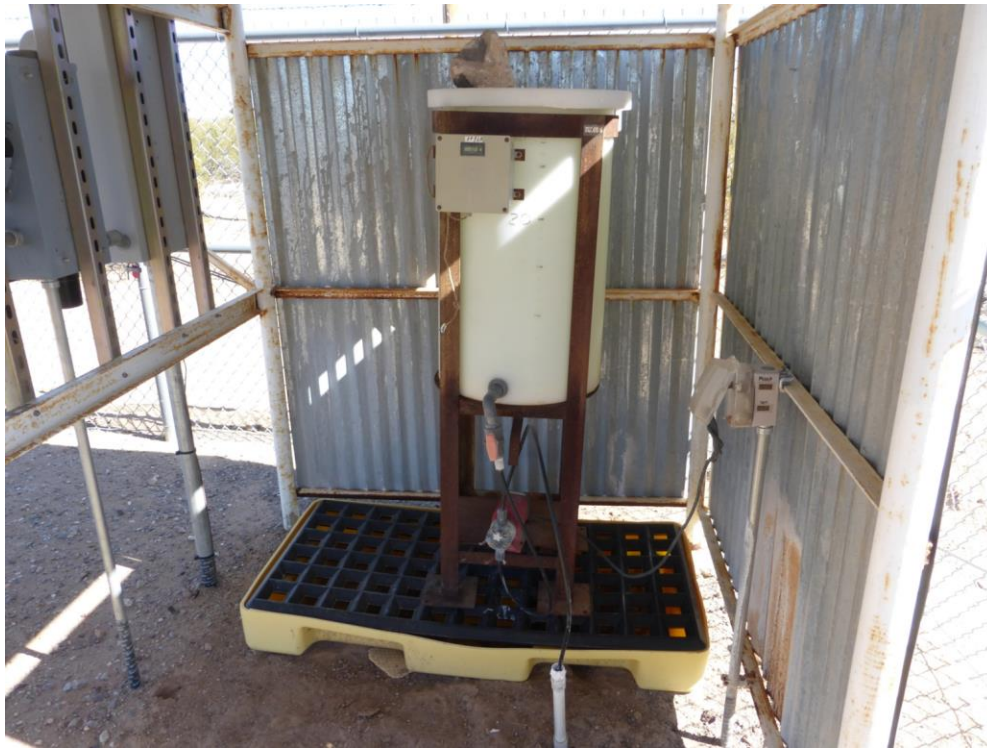
## Chlorination Unit for Well 2 (TP002)

Treatment for Well 2 consists of chlorination with sodium hypochlorite. The NSF-certified sodium hypochlorite is diluted and injected in the well's discharge piping with a ProMinent ConceptPlus positive displacement pump with a capacity of 1.03 gph.

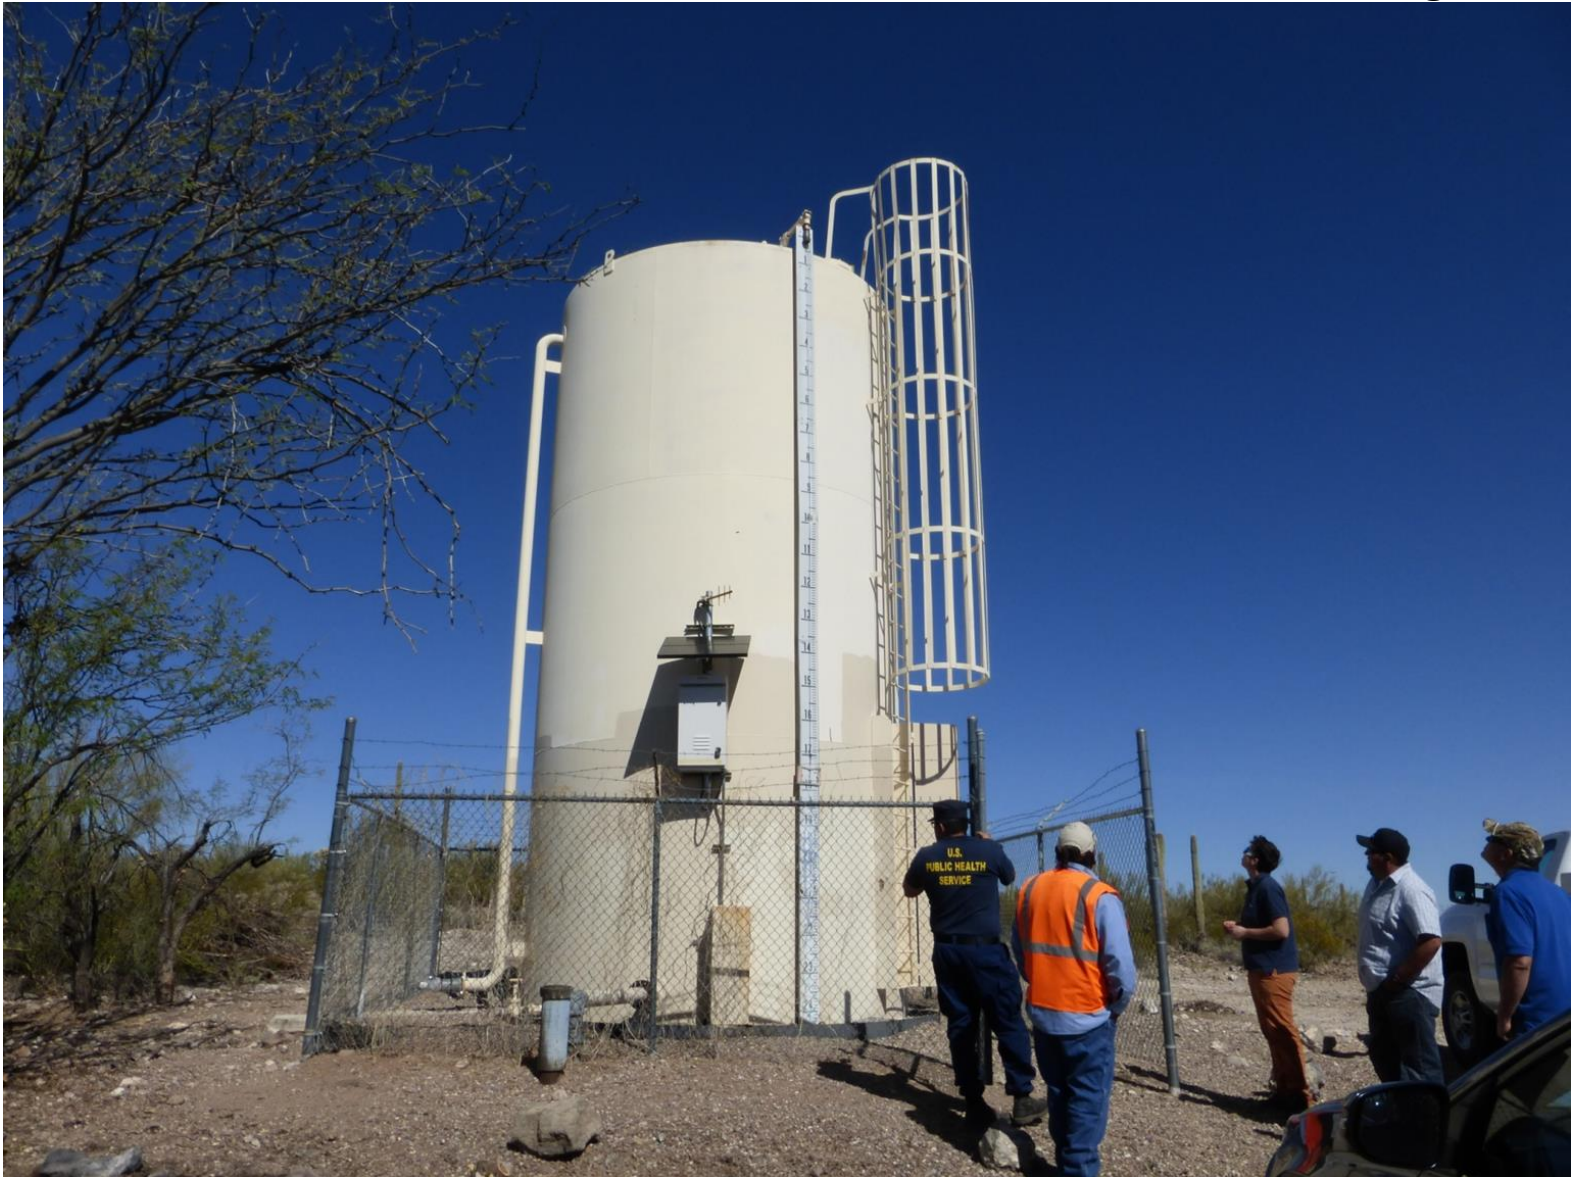
**A 20,000-gallon welded steel tank provides storage for the PWS. The tank is located within a locked fenced area approximately 2,300 feet northwest of the Well 1 location. The tank was constructed in 1985.**

**The conduit opening for the sight gauge cable is small and should prevent the entry of insects and other contaminants into the tank.**

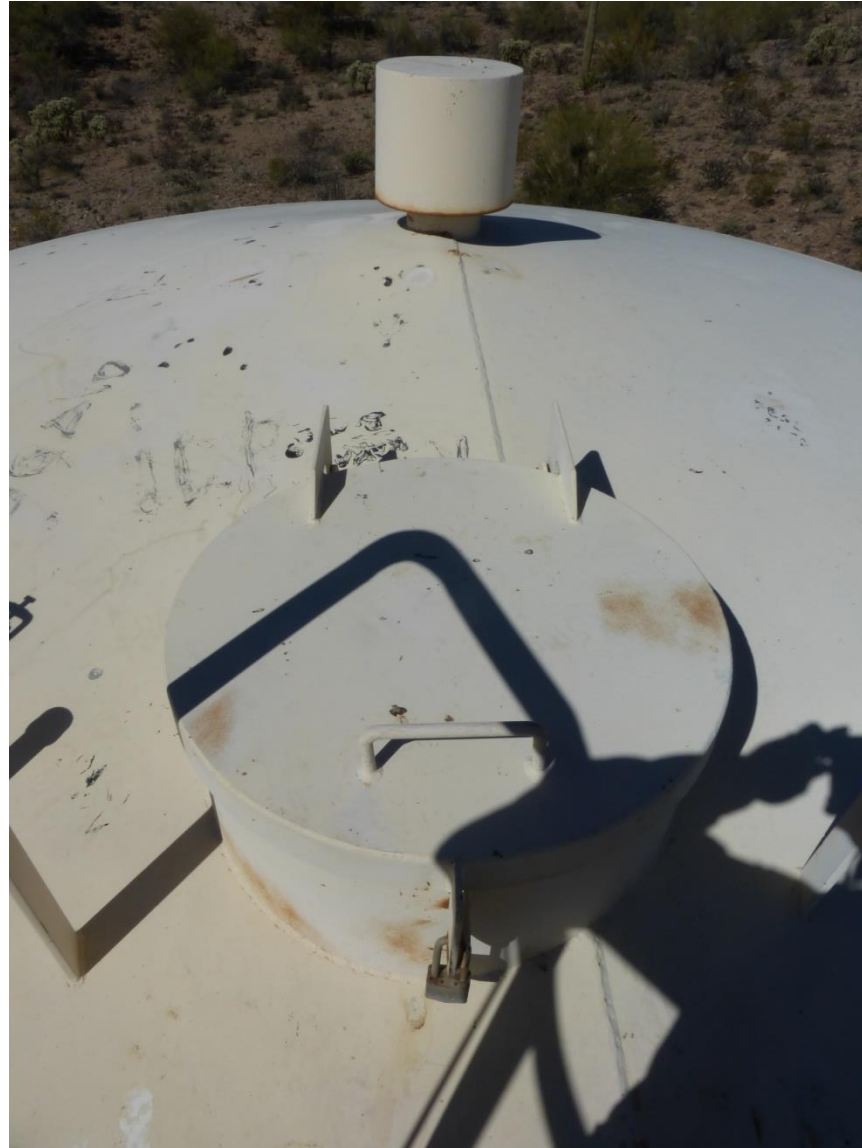
The vent screen appears torn at the top.

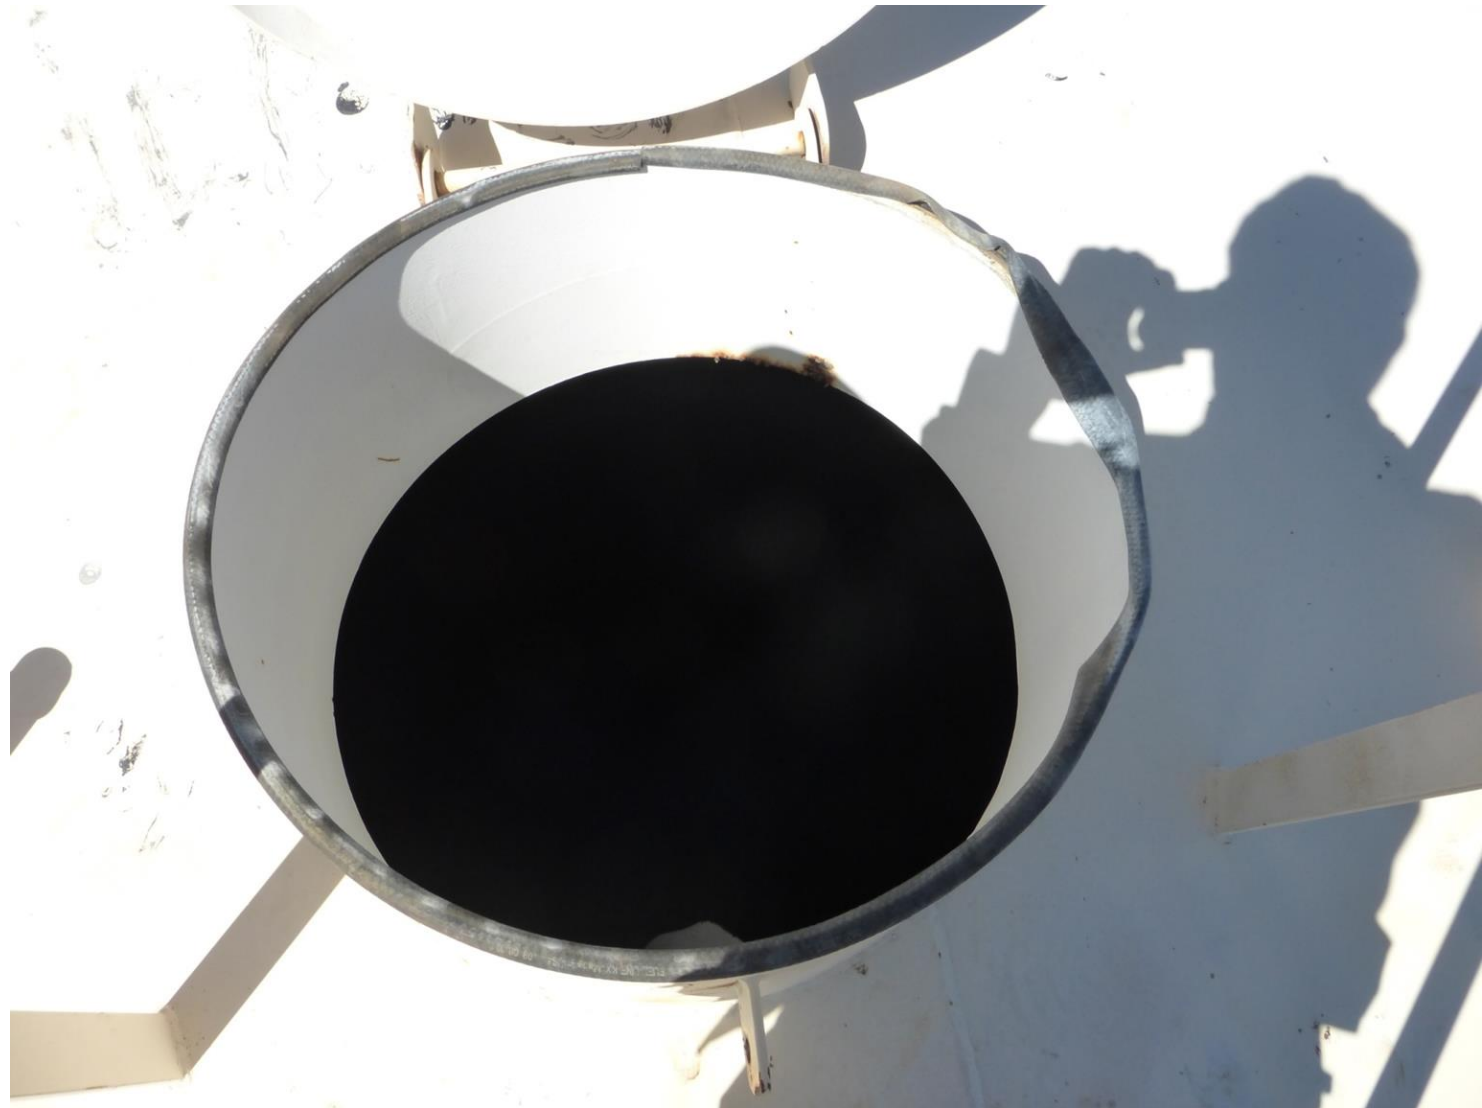
**The access hatch fits with an overlap and is gasketed; however, the gasket had come unglued at one part of the riser and was no longer providing a seal. The surveyor was able to fit the gasket back in place and close the hatch, but the seal should be re-glued. The hatch is locked.**

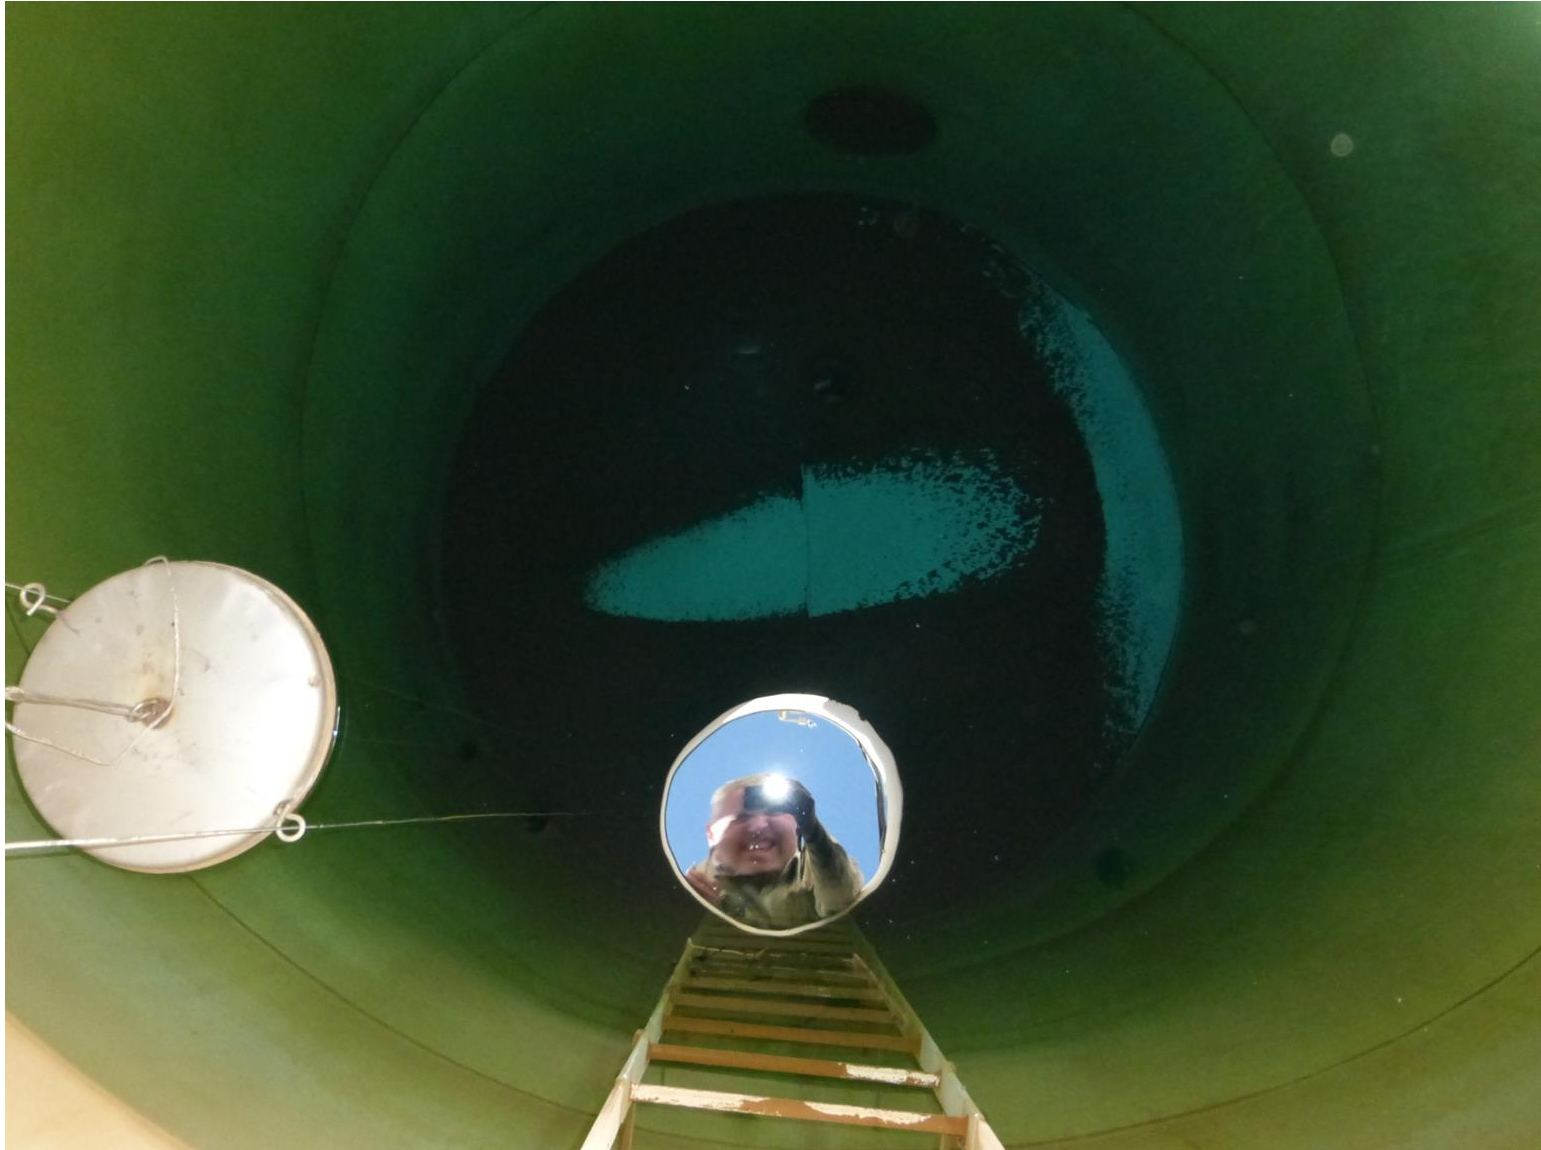
**There is a thin layer of fine sediment on the bottom of the tank.**

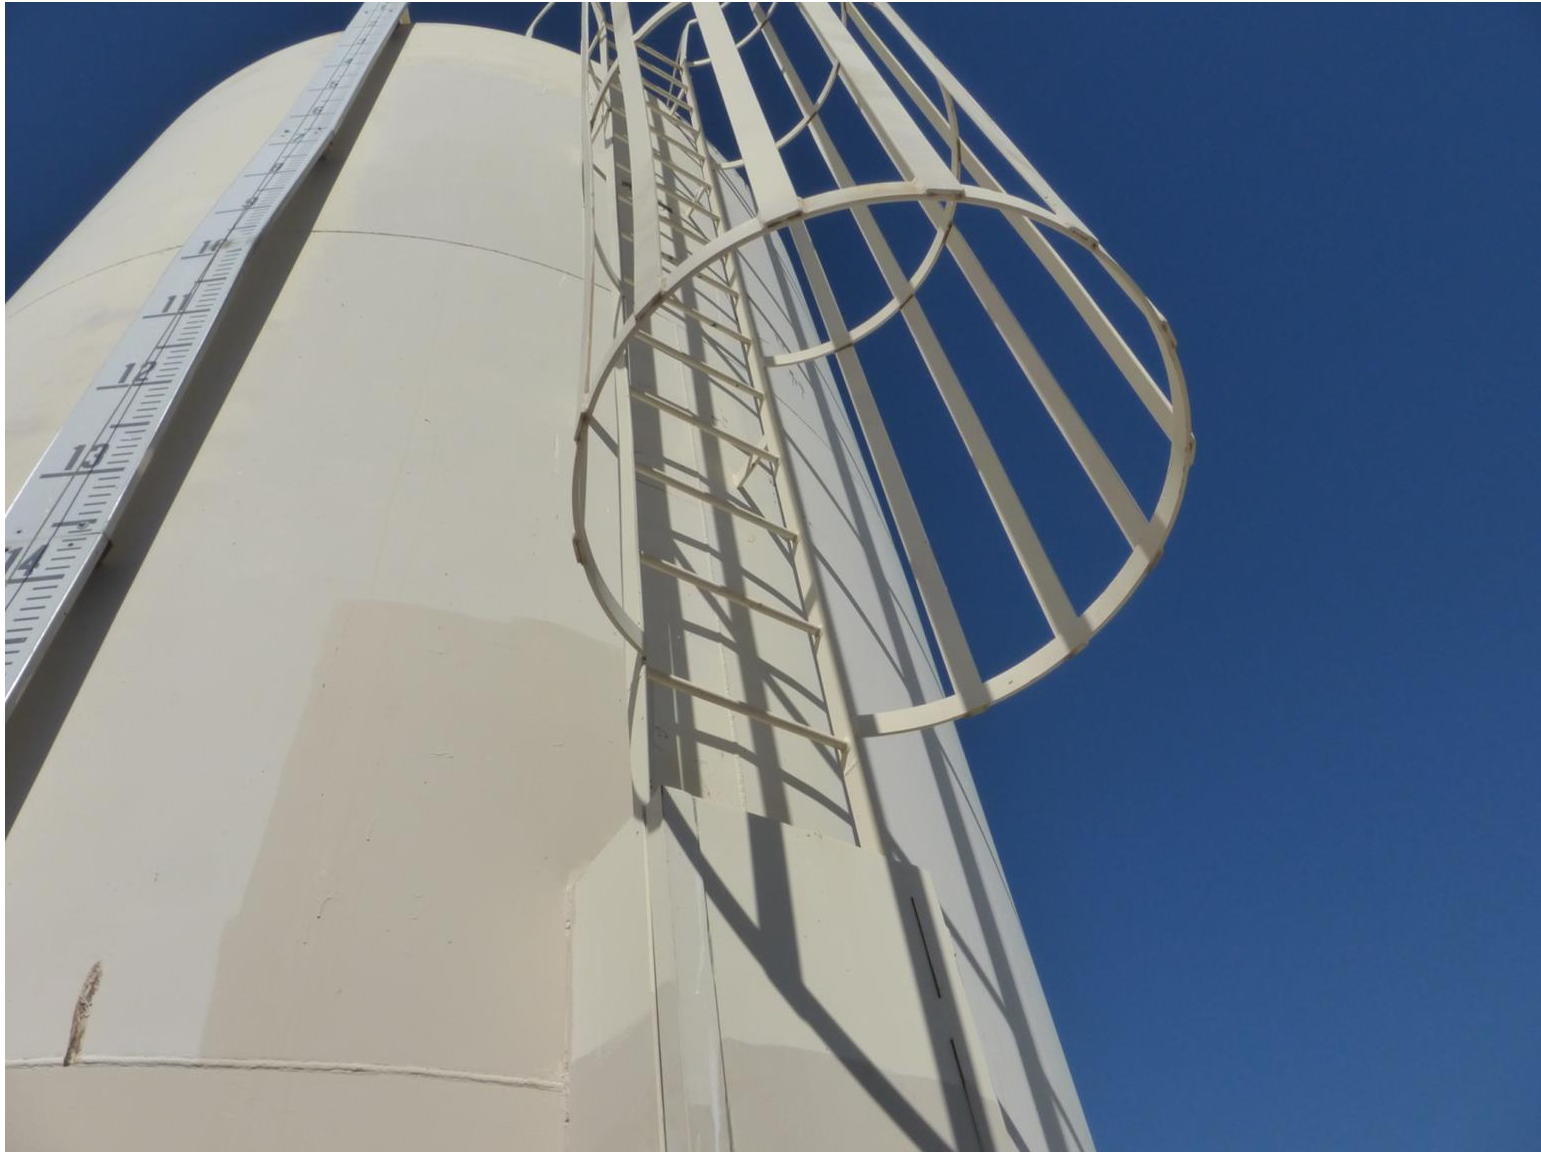
**The tank ladder is equipped with a cage. The cage opening is not equipped with a locking access cover, but the ladder is equipped with a locking cover.**

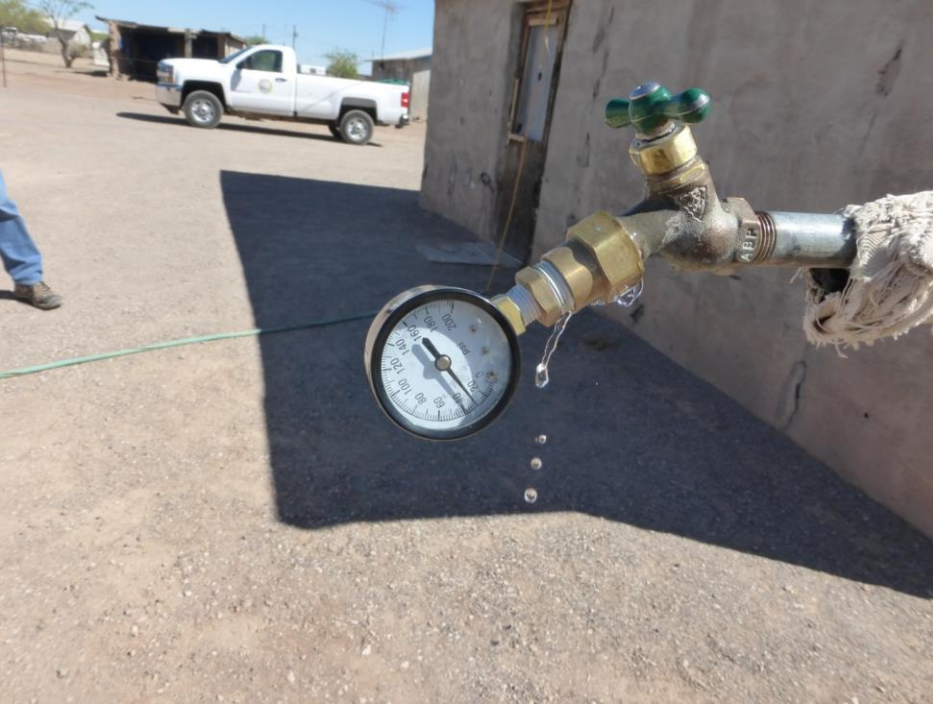
**A pressure reading taken at a home in the community showed a pressure of approximately 30 pounds per square inch (psi).**

**A chlorine residual taken at the same location showed 0.33 mg/L.**
